# Design of Dependable Systems

## Fundamentals of Aircraft Safety

### Part 1

Kristina Forsberg, Saab, Håkan Forsberg, MDH  
2019-10-23

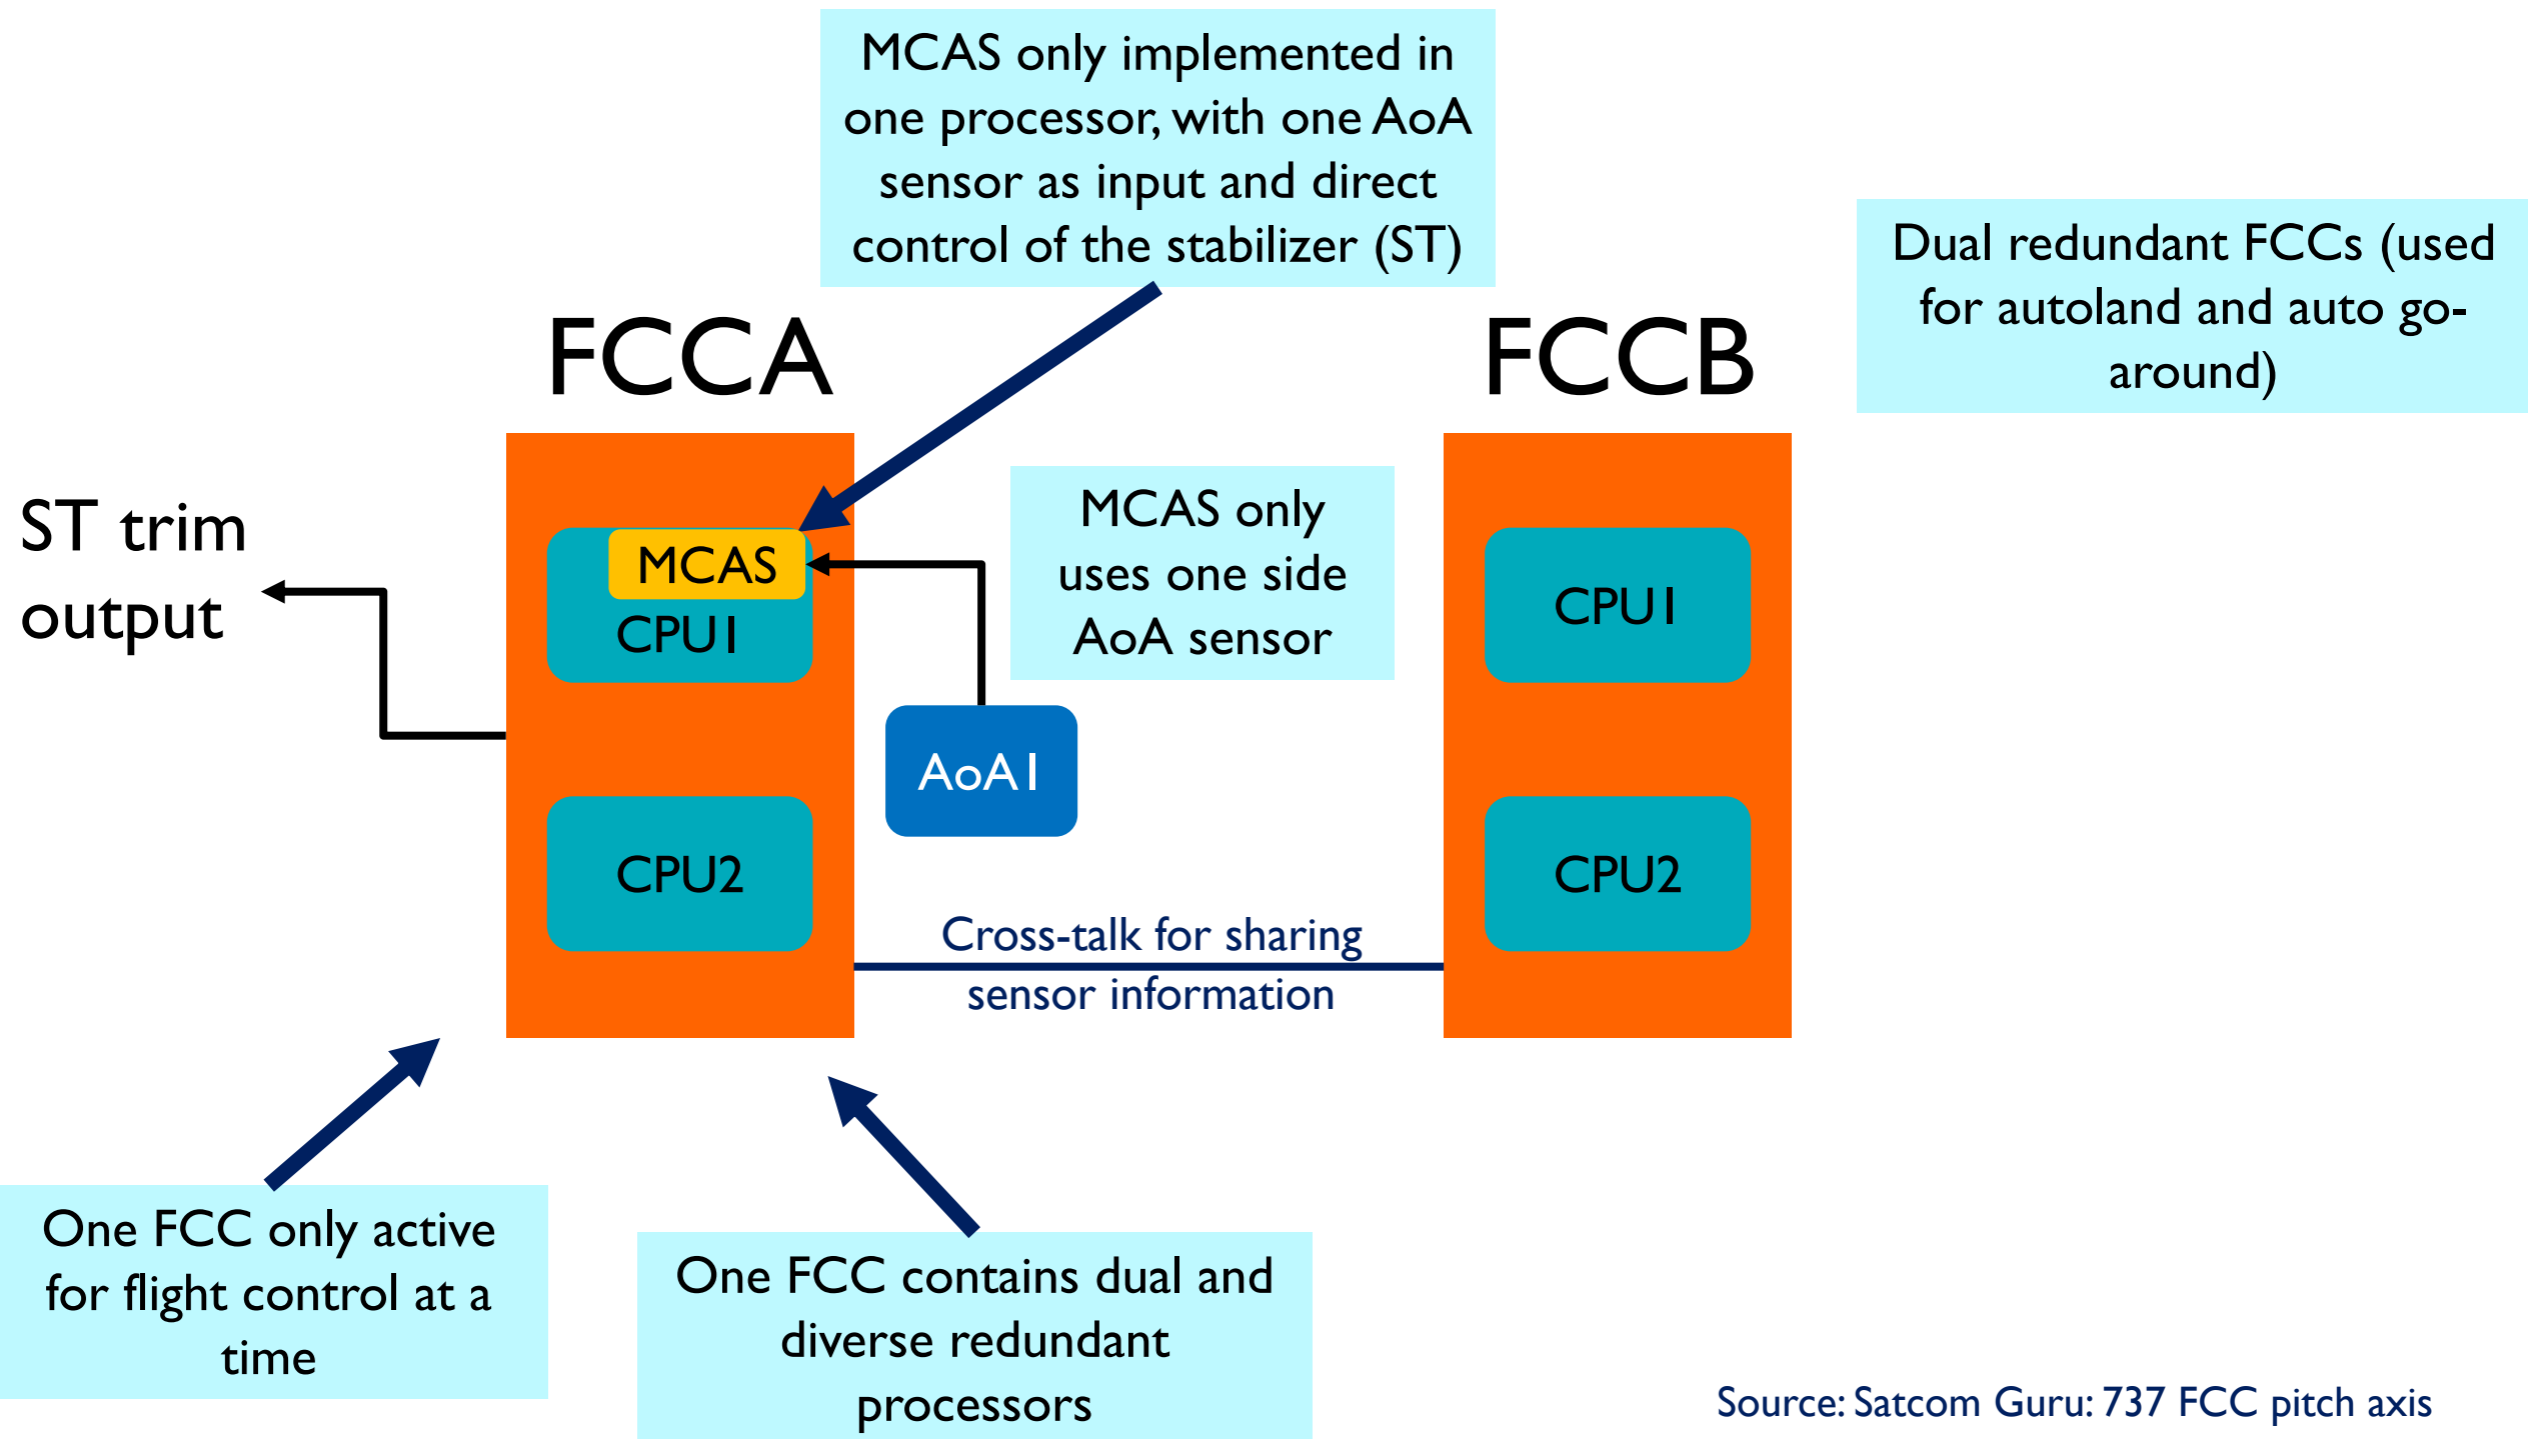
# MAX Flight Control Computers

Source: Satcom Guru: 737 FCC pitch axis augmentation – command integrity mandate for dual channel, fail-safe, Nov. 20, 2018 (which has a disclaimer of the correctness of content)
